Description

Mottled appearance consists of a dull grey circular type pattern around areas with a shiny finish. It may occur as a localised patch or extend over the entire surface of an article. The surface condition can appear in conjunction with other surface finishes, such as shiny or dull appearance and spangled areas (see *Dull Grey Appearance* and *Spangle*). Mottled appearance is also referred to as:

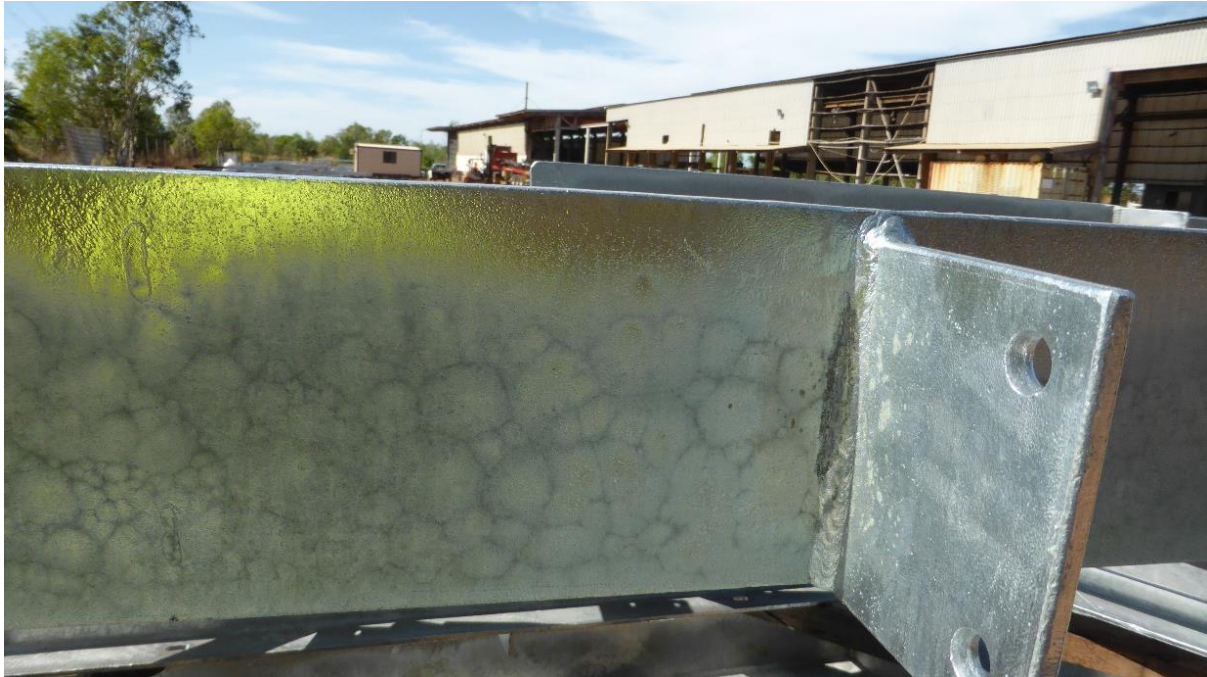
Figure 1: The dark circular pattern of a mottled appearance is visible, with the dark sections being regions of iron-zinc alloy layers on the surface.

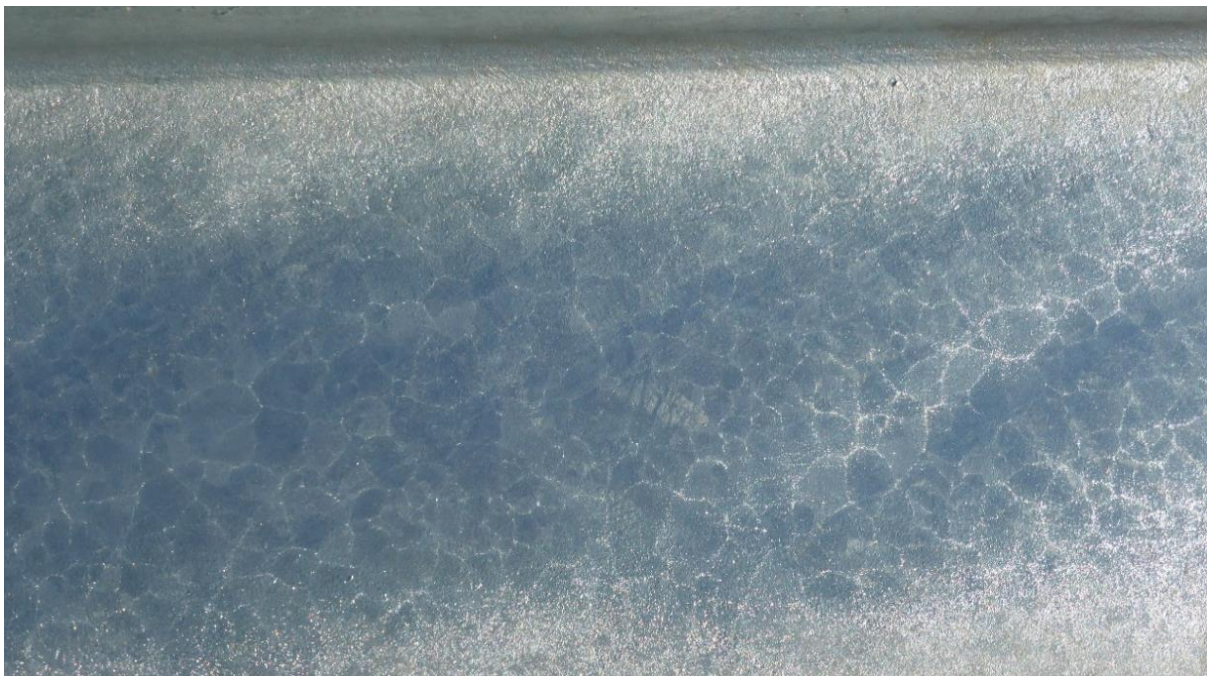
Figure 2: A close up of a mottled appearance, showing the difference between the shiny and dull regions.

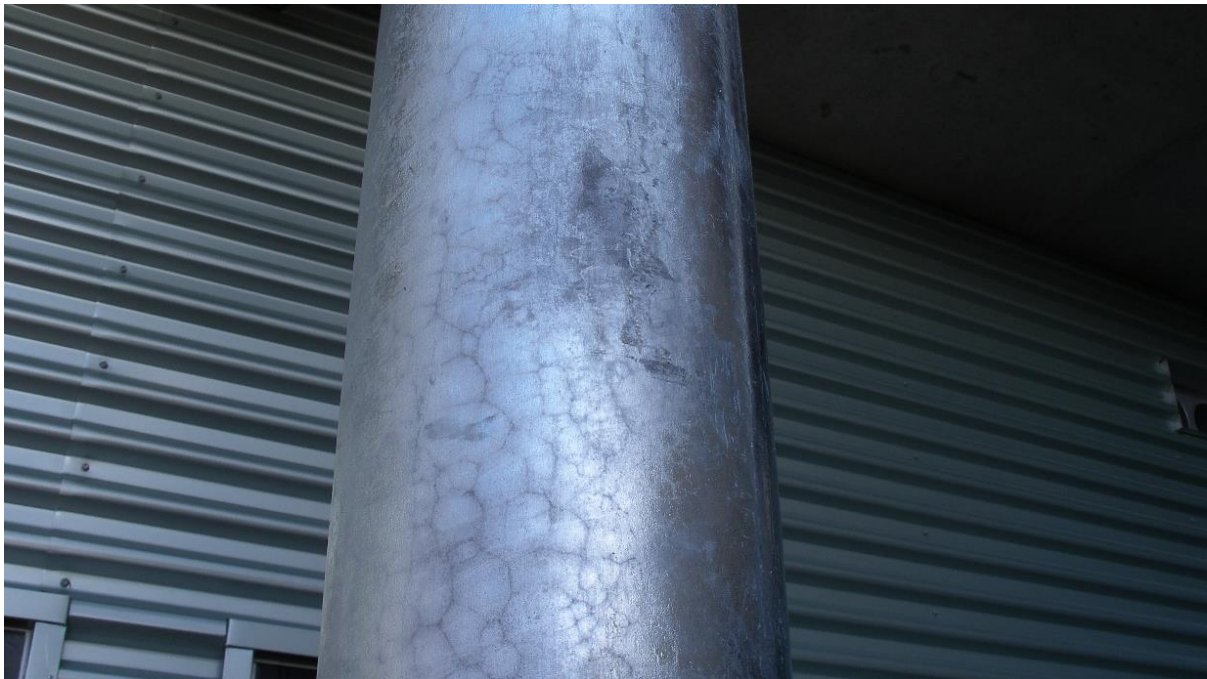
Figure 3: Mottled appearance on a pipe, most likely due to the steel chemistry.

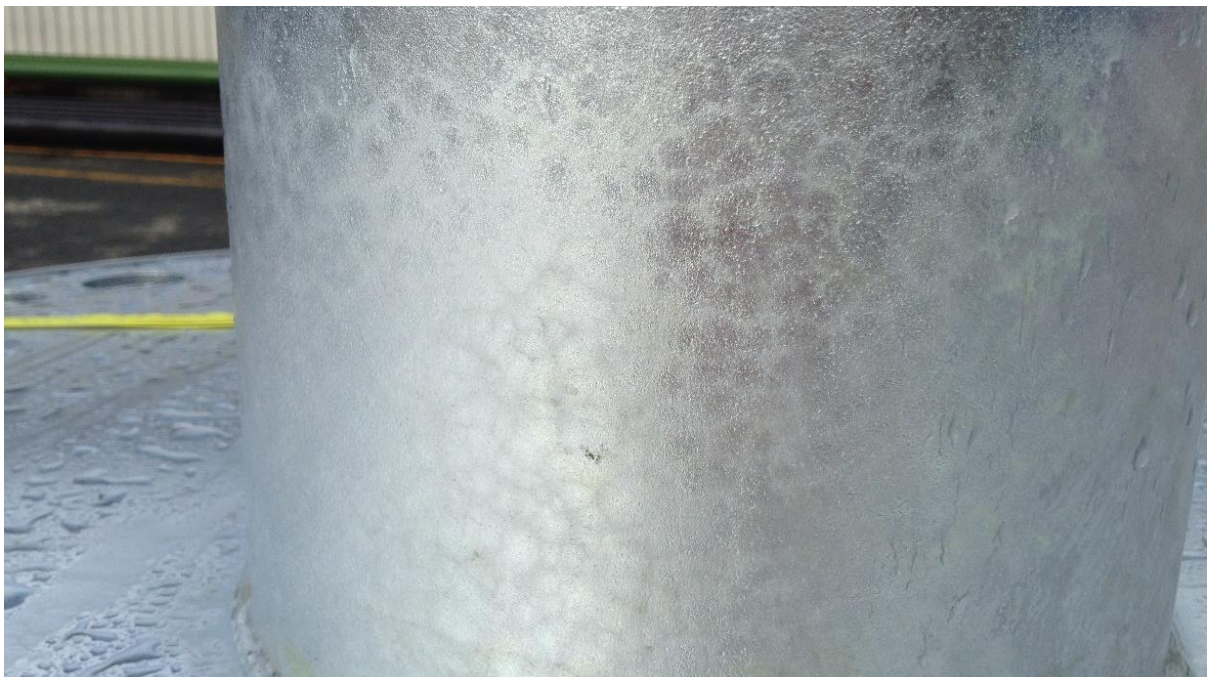
Figure 4: The scale like mottled appearance evident on a circular article.

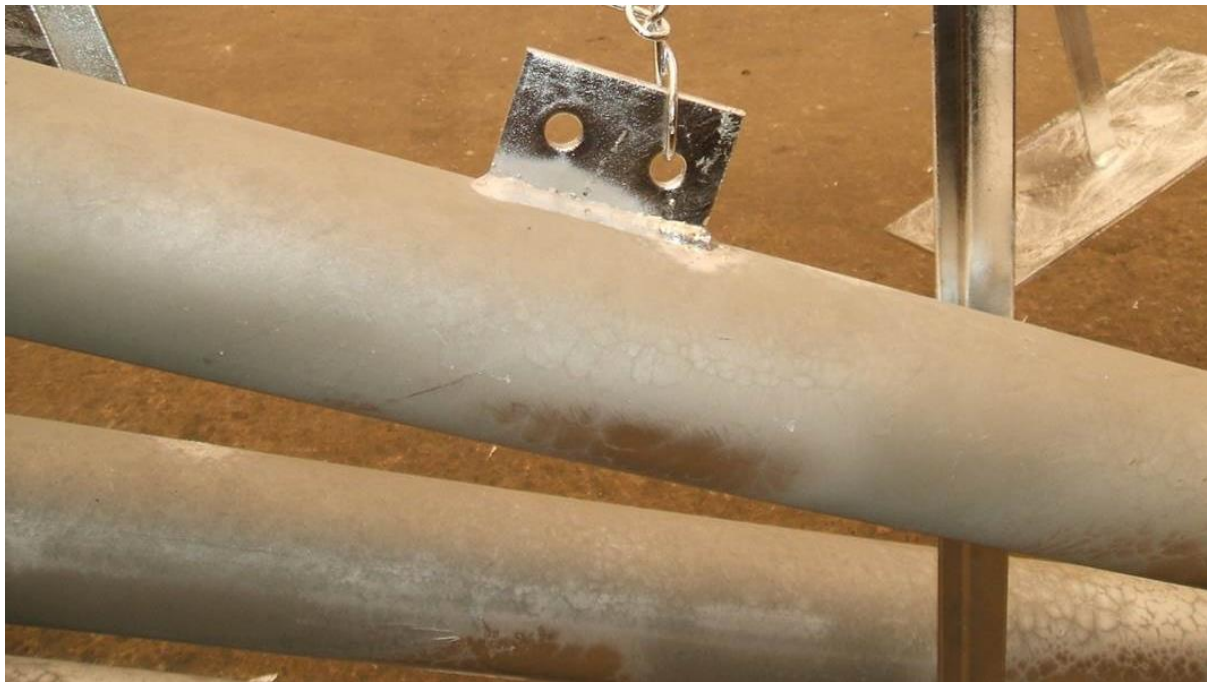
Figure 5: A mottled appearance has occurred in some regions on the pipe in combination with a dull coating (see *Dull Grey Appearance*).
